# State of Utah DEPARTMENT OF NATURAL RESOURCES DIVISION OF OIL, GAS AND MINING

# INSPECTION REPORT

Mine Name: Wellington Preparation Plant County: Carbon Permit Number:
Permittee and/or Operator's Name: Nevada Electric Investment Company (NEICO)
Business Address: c/o Mt. Nebo Scientific, P.O. Box 337, Springville, Utah 84663
Type of Mining Activity: Underground Surface Prep. Plant XXX Other
Company Official(s): Patrick Collins
State Official(s): Stephen J. Demczak Federal Official(s): None
Weather Conditions: Warm 70's
Existing Acreage: Permitted 1573.5 Disturbed 392 Regraded 1.5 Seeded 1.5
Status: Exploration Active XXX Inactive Temporary Cessation Bond Forfeiture
Reclamation (Phase I Phase II Final Bond Release Liability Year)

PERMIT NUMBER: ACT/007/012

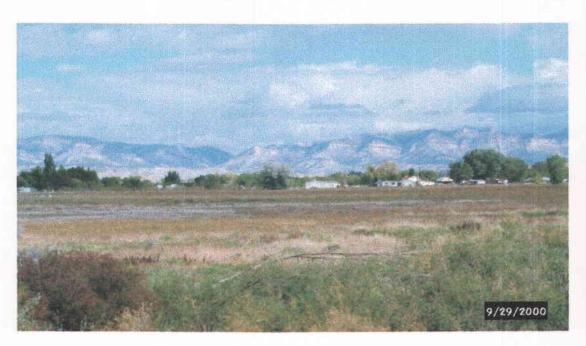
Photo #1: Mr. Siaperas' field and house

A photo was taken of Mr. Siaperas' field and house from the Wellington Prep. Plant by the Siaperas ditch as shown on Photo #1: Mr. Siaperas' field and house.

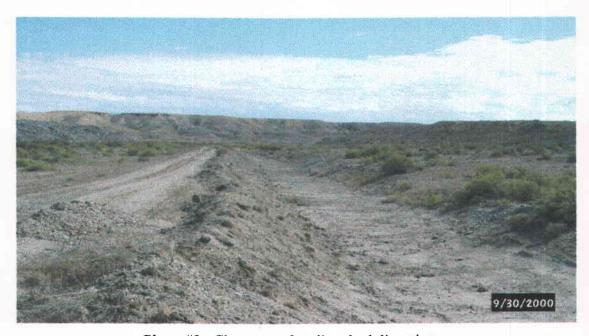
The diversions were spot-checked and were found to comply with the requirements of the Mining and Reclamation Plan and the R645 Coal Rules. The undisturbed diversion on the west side has been cleaned out as shown on Photo #2: Clean out of undisturbed diversion

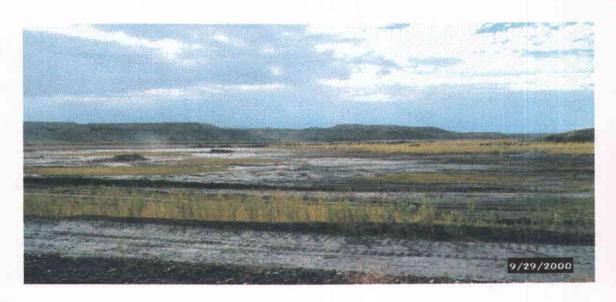
The sediment ponds were not discharging during the inspection and are not likely to discharge in the near future. These ponds did contain a little or no water. There were no signs of any hazardous conditions during the inspection. The sediment ponds were inspected on June 2, 2000 for second quarter. The inspections are P.E. certified.

Enclosed are photos showing the upper and lower slurry ponds. Photo #3: Lower Slurry Pond and Photo #4: Upper Slurry Pond.

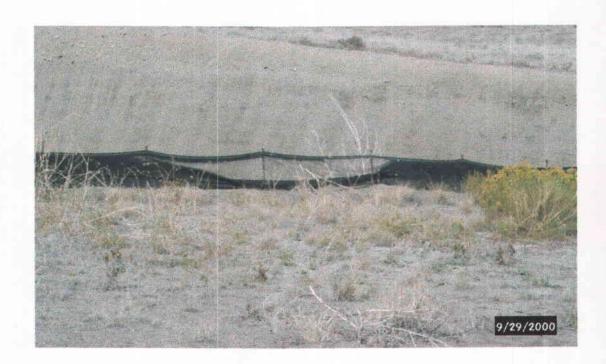
Photo # 5: Silt fence needing repair (before)

The Wellington Loadout facilities uses straw bales and silt fences as its alternate sediment control measures. These areas were spot-inspected and complied with the R645 Coal Rules. A silt fence along the Siaperas needed maintenance as shown on Photo # 5: Silt fence needing repair (before). The permittee repaired the silt fence during the inspection as shown on Photo #6: Silt fence repaired (after).
